FN-376  
2562.000  
CDF Note No. 146  
December 10, 1982

BREAKDOWN PROCESSES IN WIRE CHAMBERS  
AND PREVENTION

M. Atac

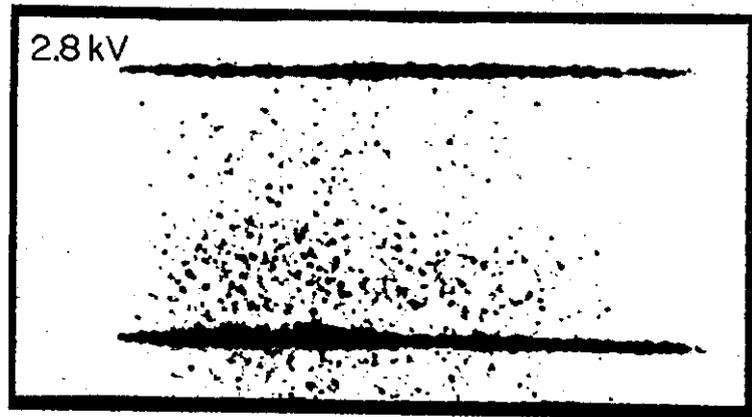
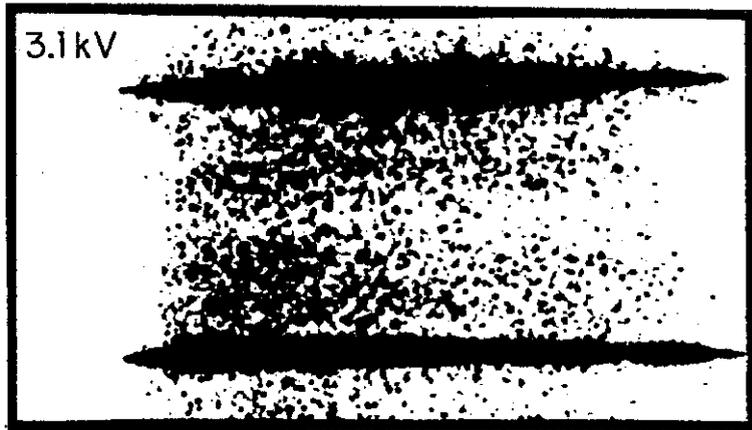
- Fig. 5 - Photon activity around the anode wires of the drift chamber at 2.5, 2.8 and 3.1 kV. The pictures are negatives of the photographs taken from the video display of the image intensifier camera.

Photon activity around the anode wires of the drift chamber makes the wires visible as shown in Figs. 5a, b and c. The source rate was  $\sim 10^5$  counts for each wire per second. The higher the gain the more photons are detectable. Some short streamers are visible at 2.8 kV (Fig. 5b). Many more can be seen at 3.1 kV (Fig. 5c). These and further pictures are the negatives of the polarized photographs for better visibility in copying processes. The photographs are 1/20th second time exposed pictures taken from a video monitor. The author believes that these photons come from some recombination processes not from normal avalanche processes. A hint for this is at low rates (less than  $10^4$ /sec) only streamers can be seen when the voltage exceeds 2.7 kV; no photons could be detected below the streamer transition. A large number of photons are emitted from the space surrounded by cathode

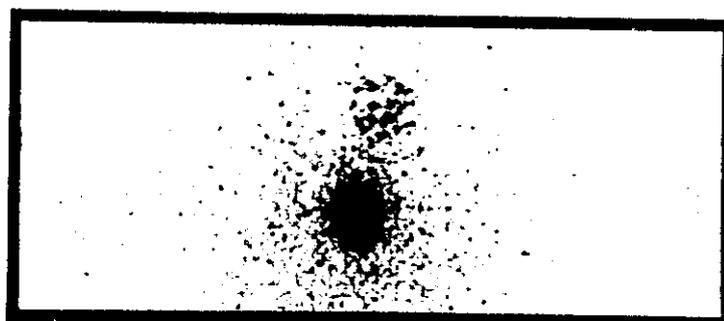
- Fig. 14 - An identical drift chamber with damaged wires. (a) hot spots on the anode wire even with 3.3% ethyl alcohol vapor in the gas; (b) hot spots remain after removing the source; (c) showing one of the hot spots that was fed by a boiling circle near the cathode wires; (d) hot spots could not be observed with 4.6% ethyl alcohol in the gas.

Hot spots were observed in this chamber up to an ethyl alcohol concentration of 3.3% in the gas mixture. Figure 14a shows the hot spots around the anode wire with the  $\beta$ -source illuminating the chamber (breakdown current of 3  $\mu$ A). Figure 14b shows that the hot spots remained after removing the source. A boiling circle showed up near the cathode that feeds one of the hot spots on the anode when the camera's sensitivity was increased (Fig. 14c). Hot spots completely disappeared when 4.6% alcohol vapor was used, as seen in Fig. 14d. The conclusion is that even a damaged chamber can be successfully used when complete UV quenching is achieved.

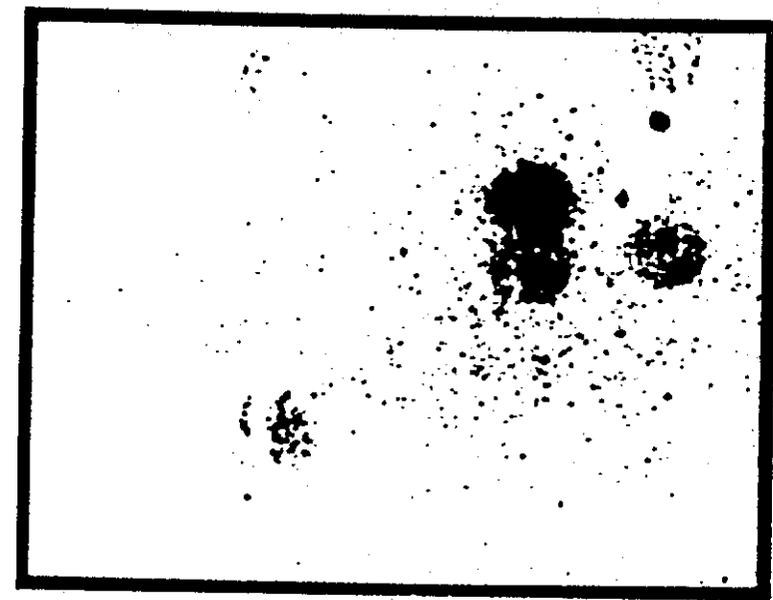
- Fig. 15 - Breakdown circles and hot spots on the anode wire of the drift chamber more dramatically seen when the ethyl alcohol was removed from the gas mixture. (a) The source is on, (b) source is off. At a rather low HV = 2 kV and 2.1 kV, average current is around 0.12  $\mu A$ .

2. What makes the streamer grow is most probably a reproduction of electrons near the streamer head by the recombination photons.
3. Another probable way of streamer growth may also occur when a highly intense beam or source is used. Coincidentally, some electrons happen to be present from another track near the tip of an avalanche cone although the critical charge density may not have been reached for regeneration of electrons by the radiative recombination photons. These accidental electrons could in succession enable the avalanche to grow into a full streamer. The streamer may grow close to the cathode. When this happens electron regeneration from the cathode could follow by the photons knocking out electrons. This condition could end up with a continuous feedback from the cathode as found in the breakdown conditions when the quenching was insufficient. This feedback mechanism continues even after removing the source (Sections c and g). Figure 15 shows some of these cathode electrons fed back breakdown circles dramatically (boiling circles).

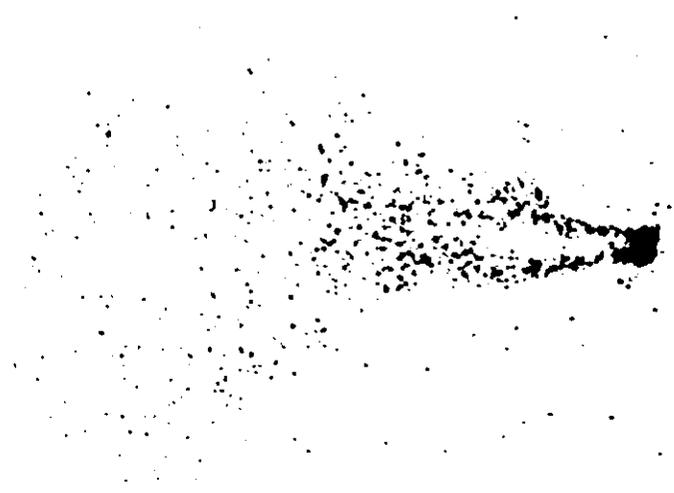
Fig. 16 - (a) A pair of branched streamers grown like a cone with the cathode fed electrons knocked out by ultraviolet photons. (b) An imaginary cone around (a). Top view of the cone is about the same size as the hot circles.

Interestingly, the circles are identical in size, about 3.6 mm in diameter (real size). Top views of some of the individual self quenching streamer pictures<sup>5</sup> very much resemble the circles (Fig. 16).
