MiniBooNE Liner Integrity Study

Phil Martin and Ray Stefanski, Beams Division

Mini-BooNE Target Hall 8 / GeV Beamline Project

Liner System Testing

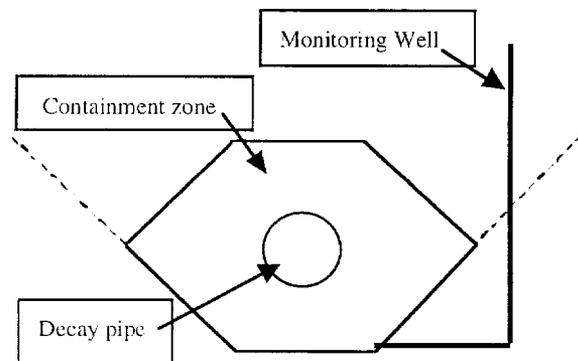
The civil construction for the MiniBooNE project includes a 50-m decay path and beam absorbers. The decay path is a six-foot diameter corrugated metal pipe (CMP). To prevent activation of the groundwater, the CMP and beam absorbers are surrounded by crushed aggregate, and enclosed in a double-walled geotextile membrane, referred to as the “liner”. The minimum distance from the beam centerline to the liner is 10’. The double-wall construction of the liner forms three regions, the containment volume, the interstitial volume, and the exterior. Each of these volumes is connected to monitoring wells at both the upstream and downstream ends of the decay volume, i.e. a total of six monitoring pipes extend to the surface. To confirm the integrity of the liner system following its placement, the firm Earth Tech¹ was contracted to perform tests. Michael Williams was our primary contact with Earth Tech. The following is the report from Earth Tech, with minor changes in the interest of clarity. A sketch of the decay region is shown below; only one of the layers of the liner is shown, and only one monitoring port. At the time of these tests, the excavation in general, but particularly in the vicinity of the monitoring wells had not been backfilled to the final grade, as indicated by the dashed lines.

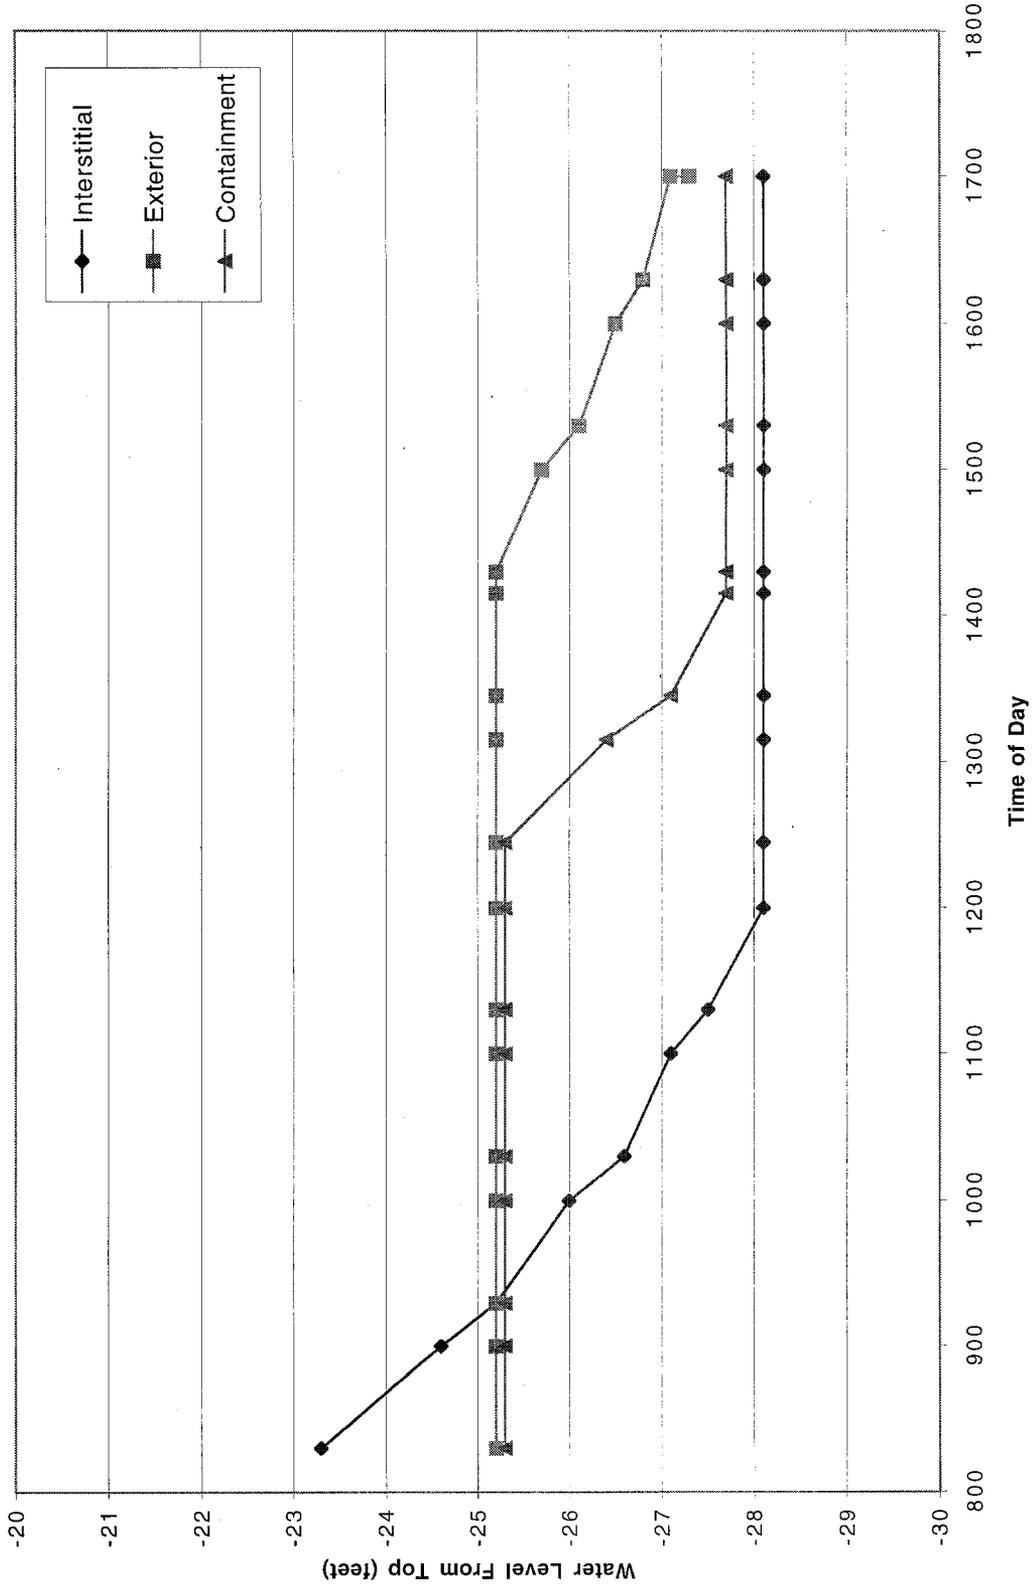
Measurements on June 26, 2001

Notes: -Depths are from top of pipe.
- Clear color indicates no dyed water present. Water may have been murky at times.

Attached to the report are tables containing the measurements, and there are graphs which display the water levels during the tests. While the data are from the tests, the graphs were generated by one of us (PM), not by EarthTech. For better visualization and for ease of compatibility with Microsoft EXCEL, the water levels have been converted to negative numbers for plotting.

On the following pages are the charts that show the levels in the wells as they were monitored. As explained in the above narrative, it was not always possible to fully evacuate liquid from each zone, but enough was removed to allow any dyed water from the interstitial zone to move through any possible leaks and be detected in the other two zones.

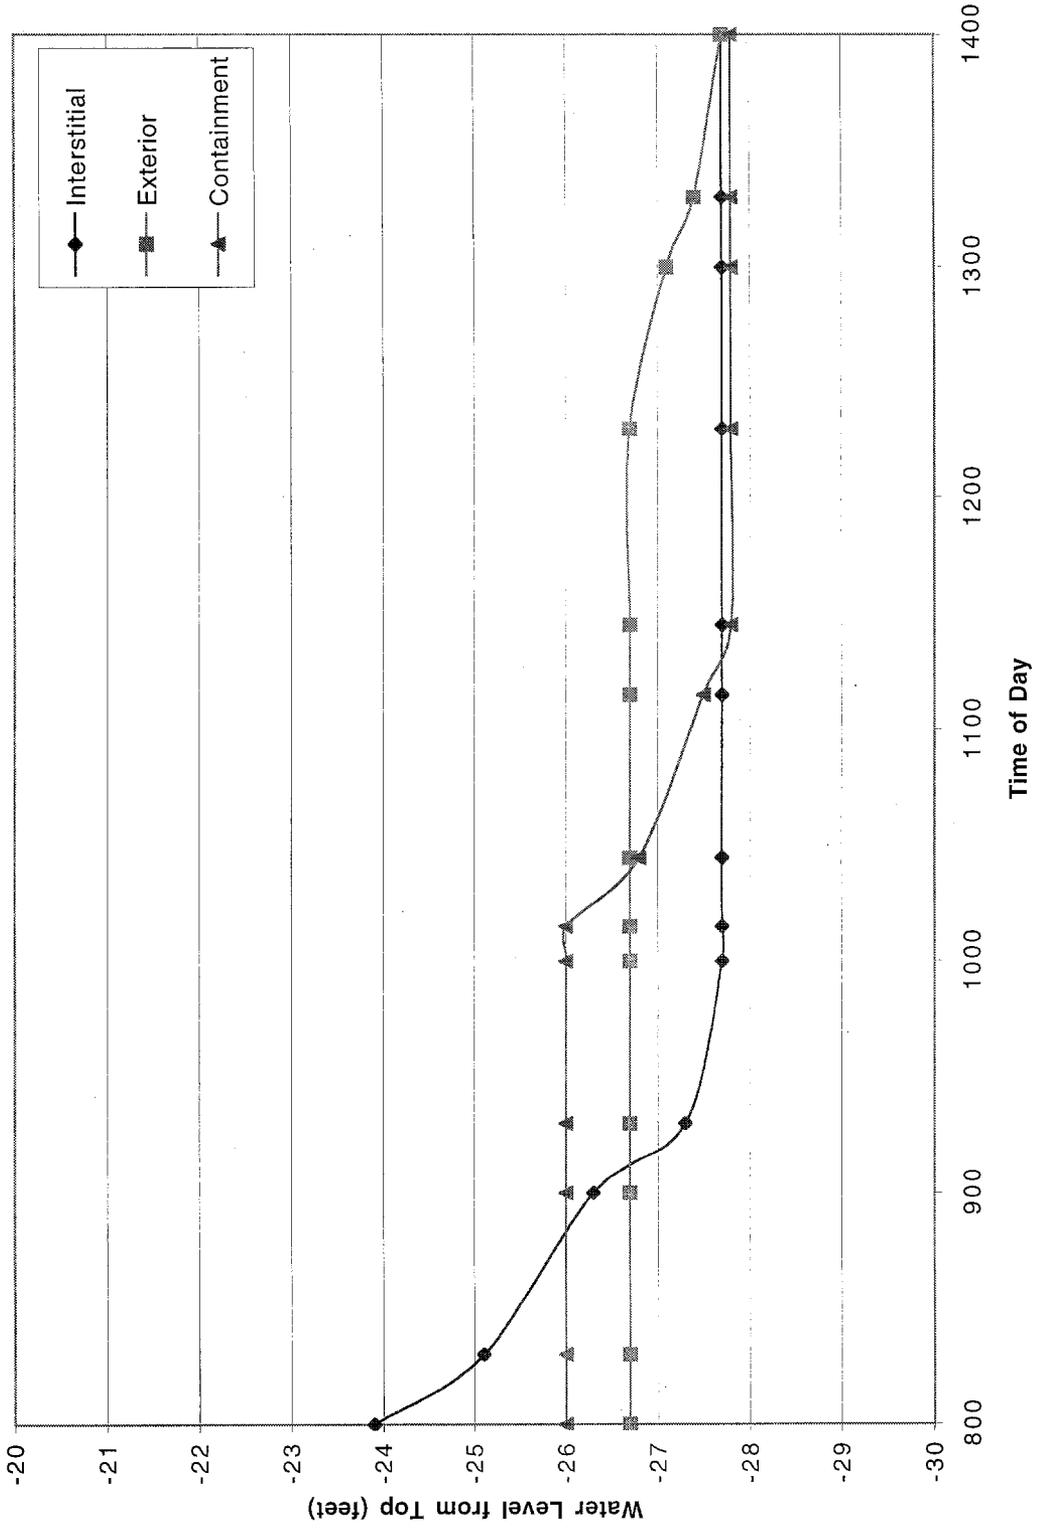
Measurements on June 27, 2001 (1)

Notes: -Depths are from top of pipe.
- Clear color indicates no dyed water present. Water may have been murky at times.
